**Indoor Air Quality Assessment
MCCT
Cambridge District Court
40 Thorndike Street
Cambridge, Massachusetts**

INDOOR AIR QUALITY ASSESSMENT

**Cambridge District Court
Middlesex County Courthouse
13th, 14th & 15th Floors
Cambridge, MA**

Prepared by:
Massachusetts Department of Public Health
Bureau of Environmental Health Assessment
March, 1999

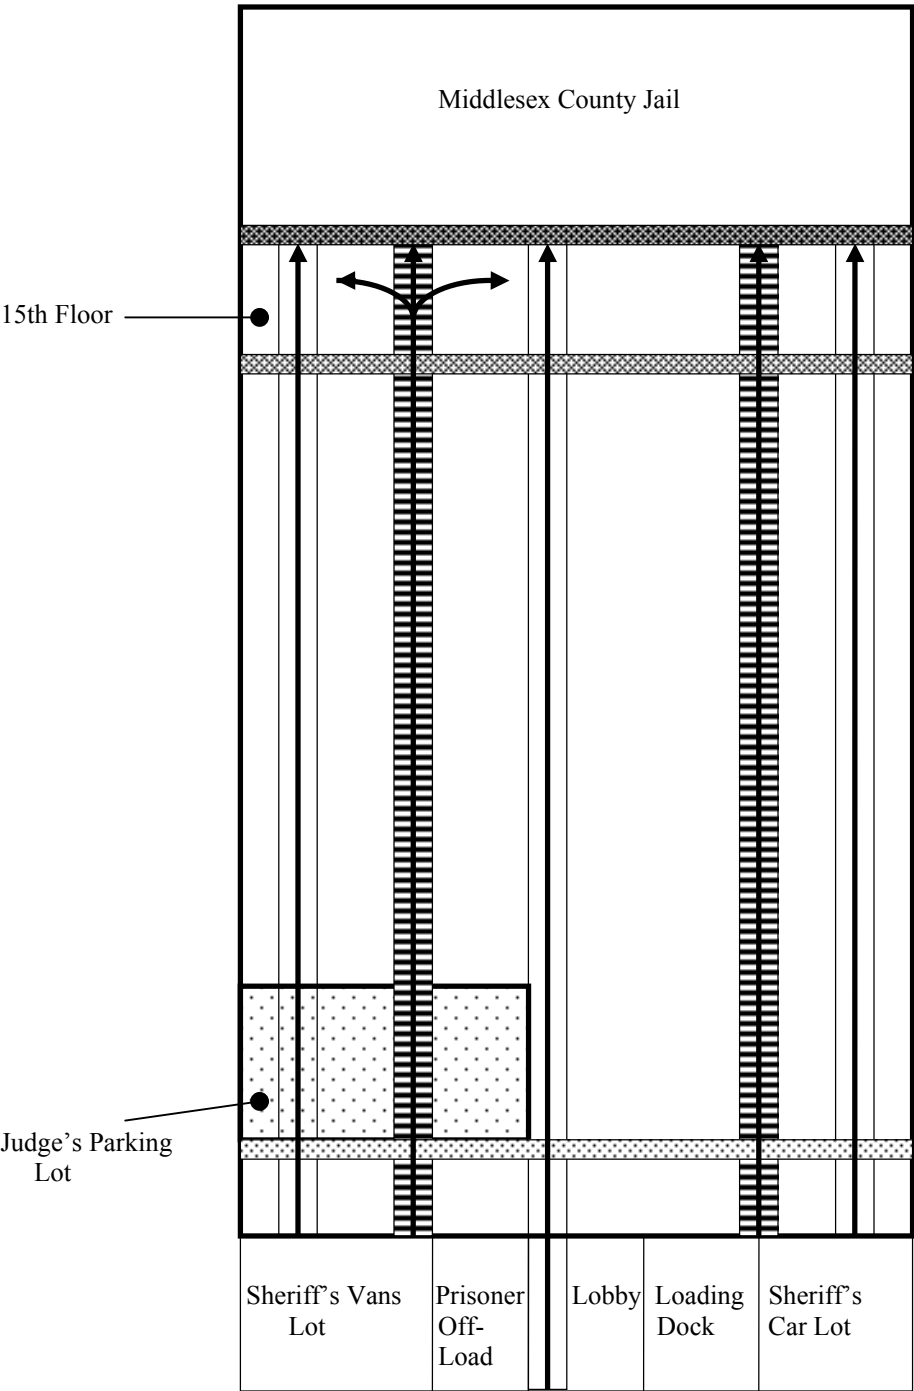
Figure 1 Air Movement Up Stairwells and Elevator Shafts
of the Cambridge District Court Building

Each stairwell terminates at the 16th floor. The 17th through 23rd floor contains the lockup, which is on a separate HVAC system from the rest of the building. This makes the top of each stairwell an enclosed tube, at the top of which heated air from lower floors can rise and pool (see Figure 1). As demonstrated by the soot deposits on the stairwell ceilings, it appears that fossil fuel exhaust is also mixed with this rising heated air. This is noteworthy because of the previously mentioned soot depositions in the vault, fresh air diffusers and ceiling tiles. This stairwell door is kept ajar to allow for ease of passage between floors. The vault in the clerk's office is roughly opposite to the door to the stairwell of the clerk's office, which has black soot deposition above fluorescent lights. Air diffusers nearest this open door in the halls and main office appear to have the heaviest soot deposition. Noting these conditions, BEHA staff attempted to locate a source of fossil fuel exhaust that appears to be impacting on the 15th floor.

Finally, air movement from the basement to the 15th floor is the multiple elevator systems may also be a concern. Most of these elevator shafts terminate at the 15th and 16th floors and therefore provide a similar route to these floors as do the east and west stairwells. In addition to the stack effect, elevators can draw pollutants into the elevator shaft while cars operate. This piston effect can serve to place the basement elevator lobby under negative pressure as cars move upwards, which can then enhance the penetration of vehicle exhaust into occupied areas and hallways through doorframes, and other holes in wall and ceilings.

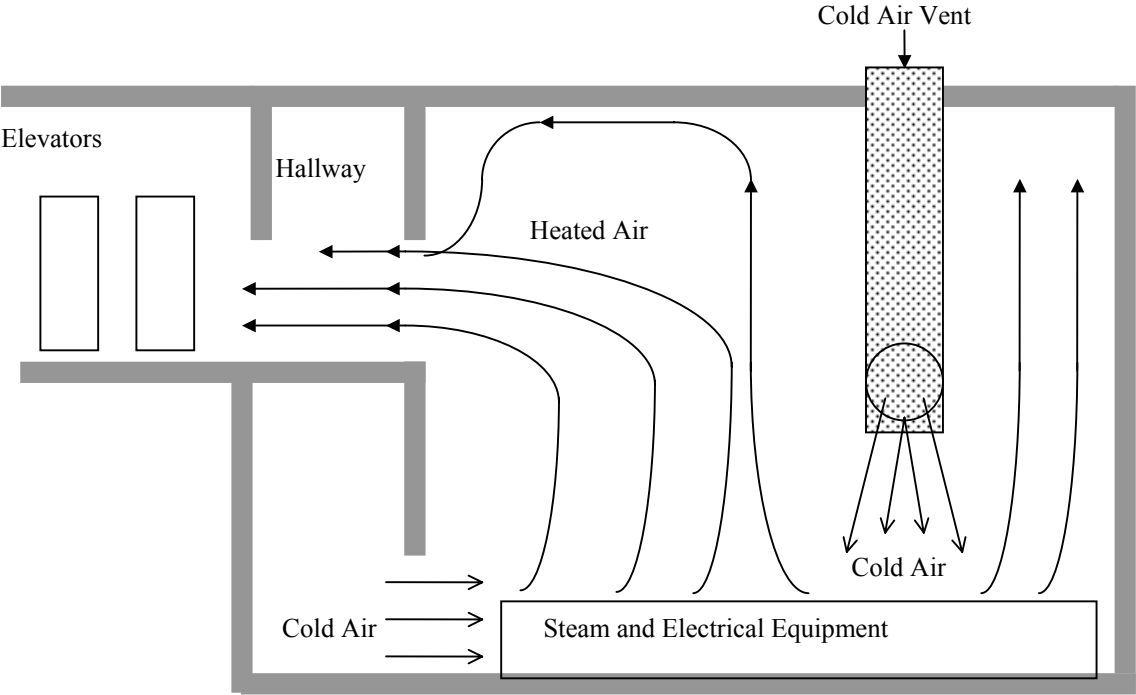
Figure 3 Air Movement Created by the Steam Mechanical Room

Enhancing the movement of vehicle exhaust is the movement of waste heat from the steam mechanical room. The steam mechanical room, whose floor is located in the subbasement, has a door that is permanently wedged open at the basement level opposite the elevator lobby (see Figure 2). The door that serves as the sub-basement entrance to the steam mechanical room is permanently ajar, which creates an air current producing airflow from the steam mechanical room into hallways (see Figure 3). Enhancing this effect is a vent that introduces cold air into the steam mechanical room, which places this area under positive pressure to force heat into hallways. Since the building does not use combustible fuels, it is unclear as to the purpose of this fresh air vent. Because the steam mechanical room produces large amounts of waste heat, it is possible that this vent should be an exhaust vent, which will draw heat out of the steam mechanical room.

1. Consider the installation of mechanical exhaust ventilation to vent vehicle exhaust outdoors. These systems should create negative pressure to prevent vehicle exhaust penetration into the building interior.
2. Ascertain the purpose of the supply vent in the steam mechanical room.
3. Consider replacing air diffusers in courtrooms with ones that are designed to direct cold air away from jurors. If not possible, consider rearranging the configuration of these courtrooms to move seated individuals out from underneath air diffusers.

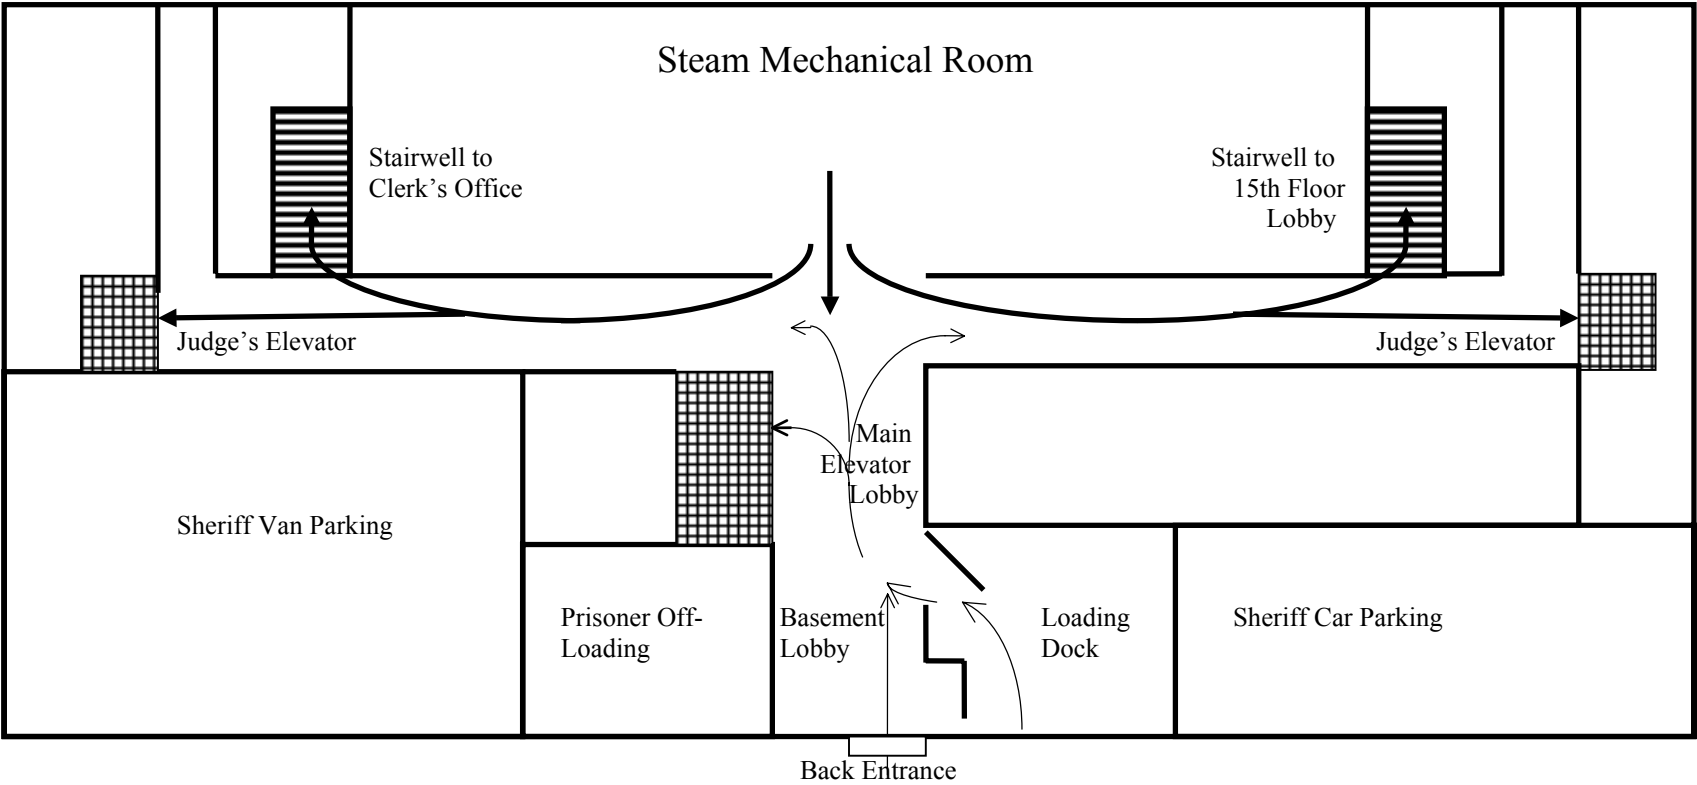
Figure 2

Several indoor parking areas exist in this building: the sheriff's department van parking, the sheriff department car parking, the prisoner van entrance and the building loading dock (Figure 2). In addition, the judge's parking lot exists indoors on the first floor above the sheriff's department van parking. With the exception of the judge's parking lot, none of these parking areas have exhaust ventilation. As motor vehicles operate indoors, the production of vehicle exhaust in combination with cold air moving from outdoors through open exterior doors into the warmer garage can place the garage under positive pressure.
